TURBIDITY MONITORING AT SELECT MDOT CONSTRUCTION SITES

STATE STUDY 225

JUNE 2012

**Prepared for:
Mississippi Department of Transportation**

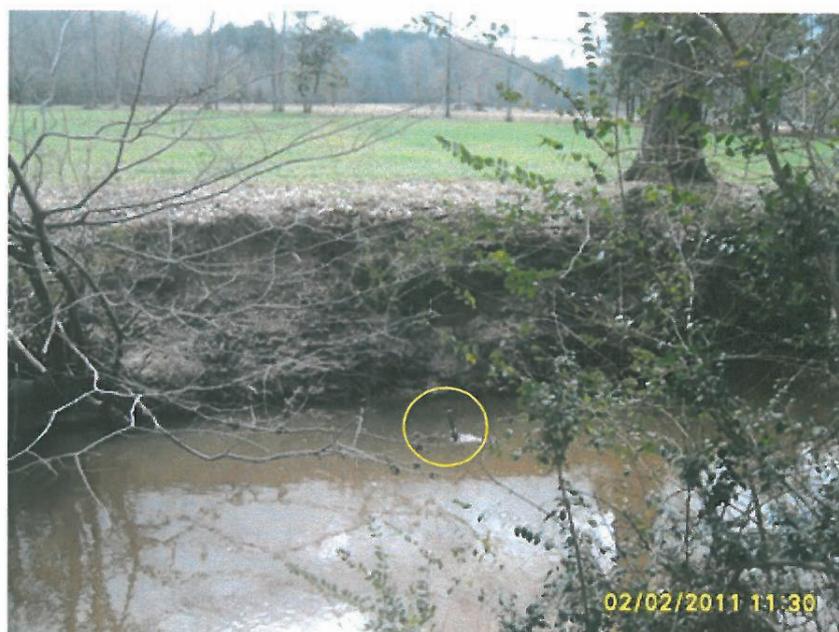
Photo A-2 Upstream sampling location Troll in place

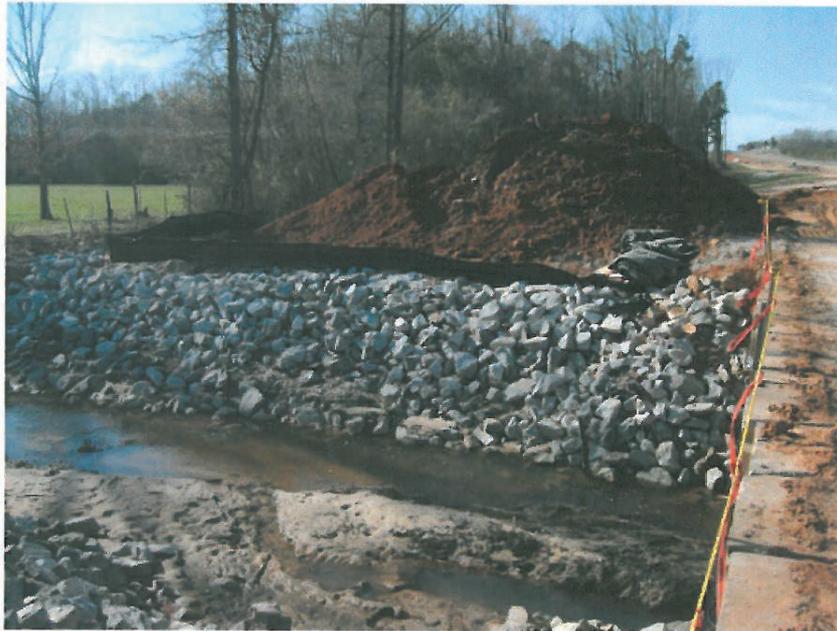
Photo A-7 Rip rap lined bank and silt fence around stock pile of dirt

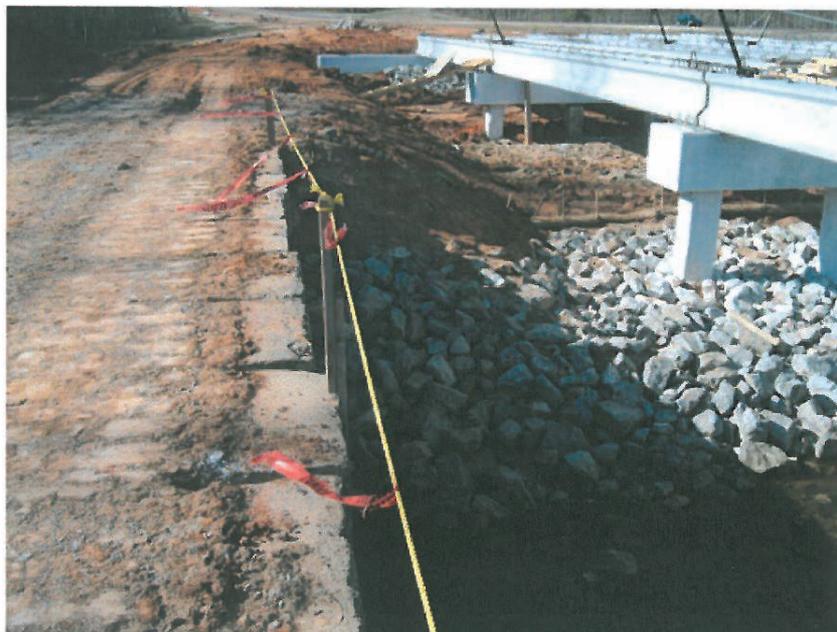
Photo A-8 Rip rap lined embankment with waddles installed at the top

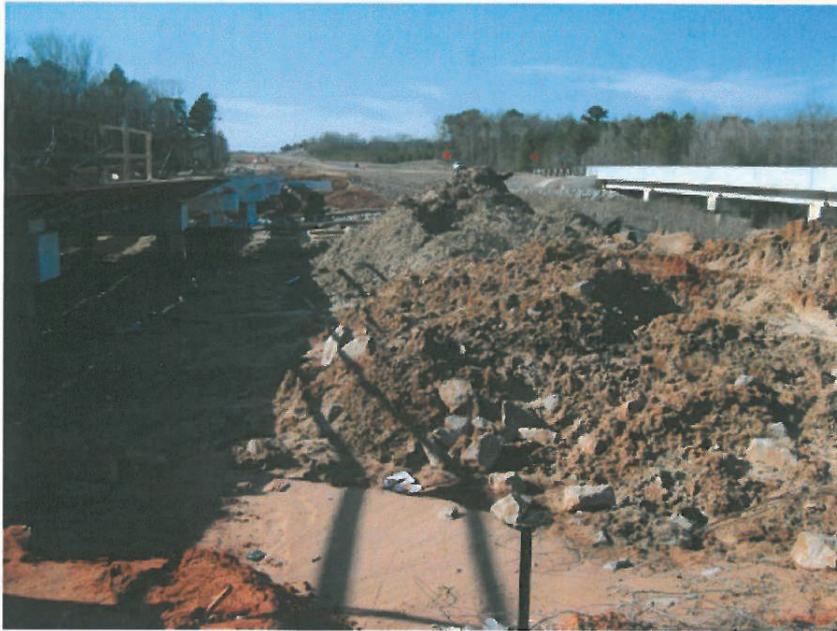
Photo A-9 Evidence of sedimentation at the bottom of unprotected slopes

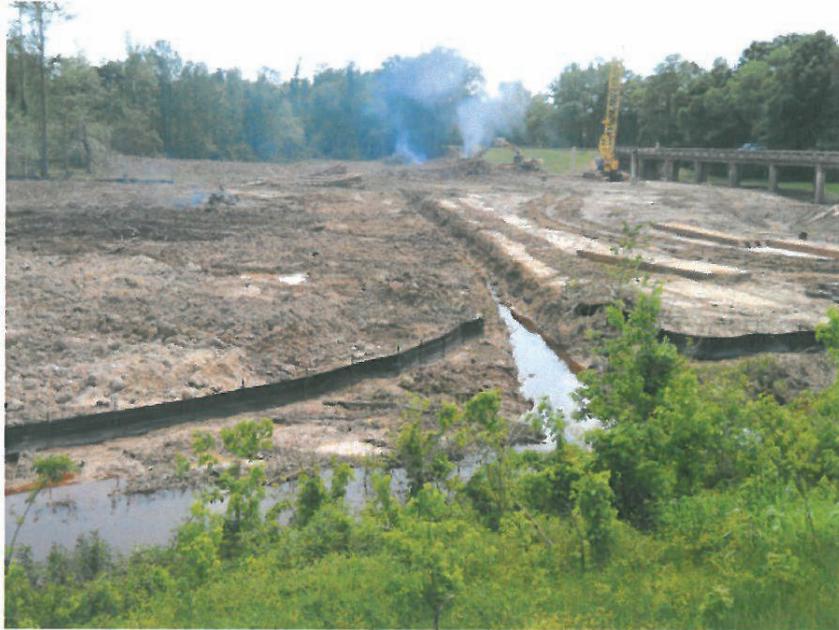
Photo B-1 Silt fence installed on the bank of the main stream

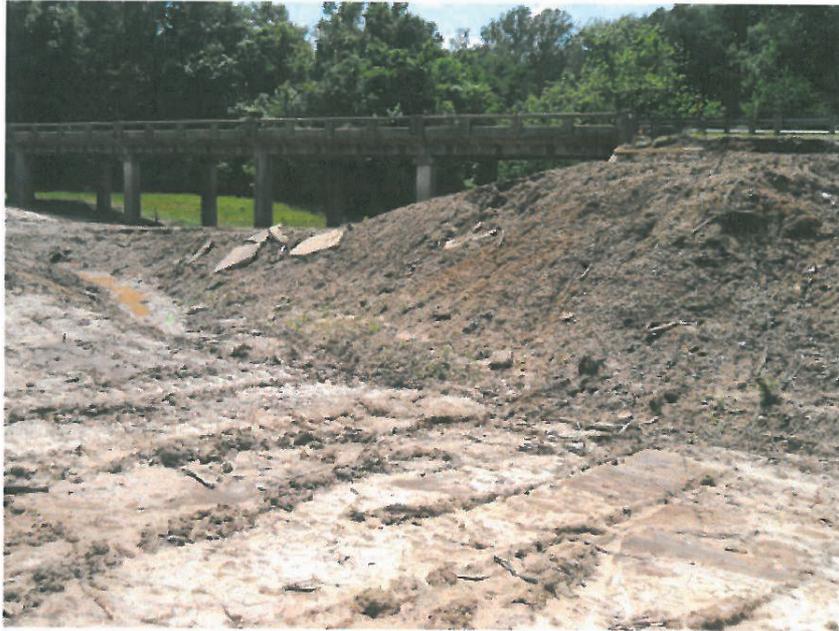
Photo B-3 No vegetation or BMPs in place on the slope

Erosion and sedimentation control BMPs on the site were minimal. The site did have a silt fence around the perimeter, but it was damaged and/or held sediment in several places. Slopes on the site were left unprotected with very little to no vegetation in place. Ditches throughout the site were unlined with no wattles or rock check dams in place.

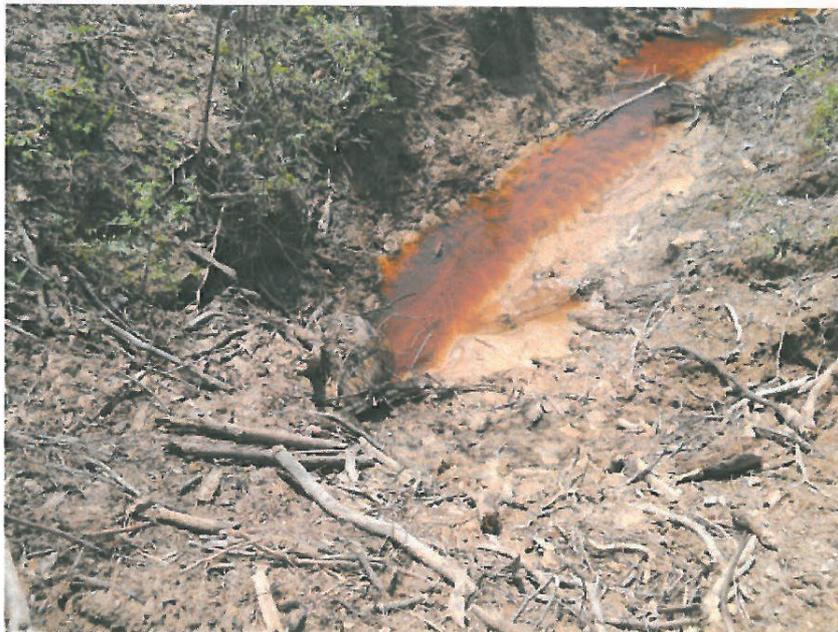
Photo B-4 No BMPs in place to prevent sediment from entering the stream

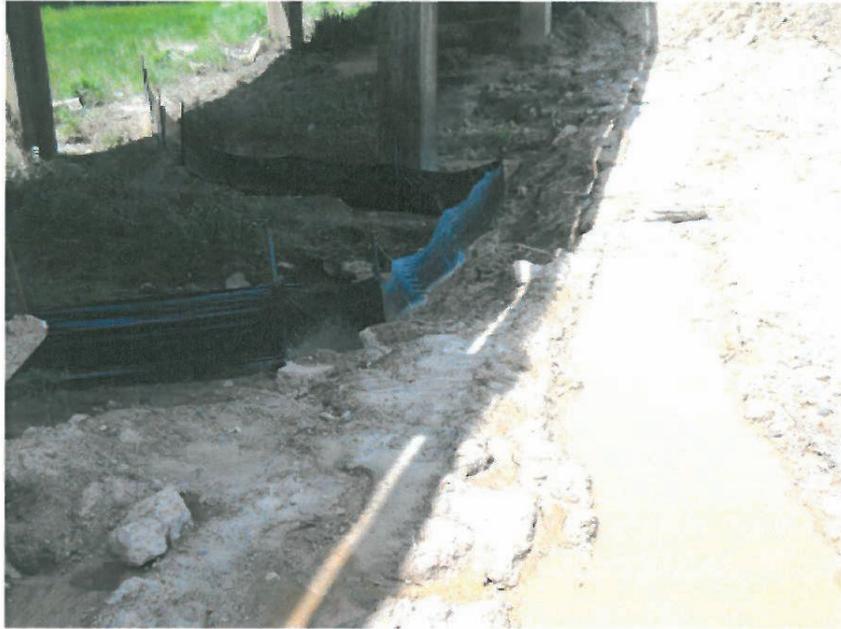
Photo B-5 Silt fence installed near an existing ditch that leads to the stream

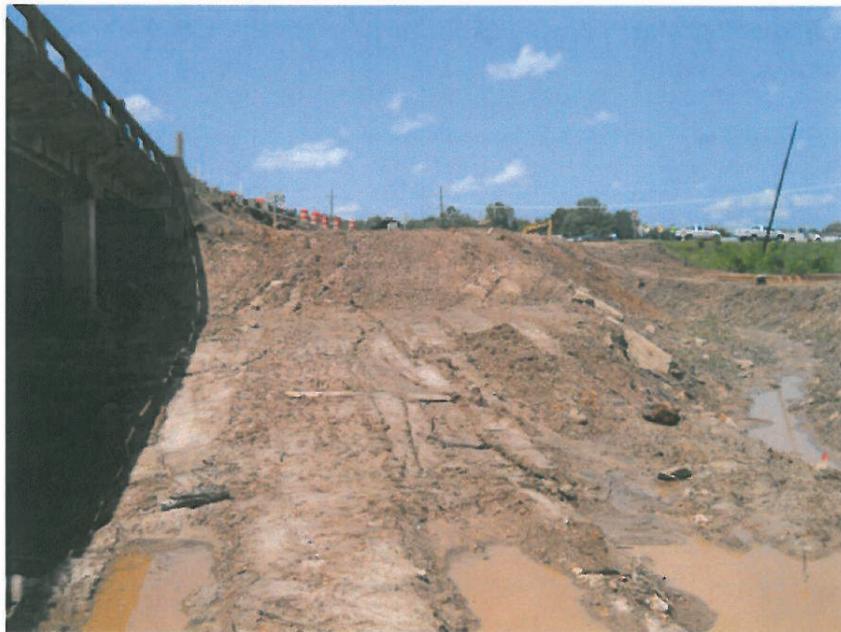
Photo B-6 Unprotected slope with no BMPs in place

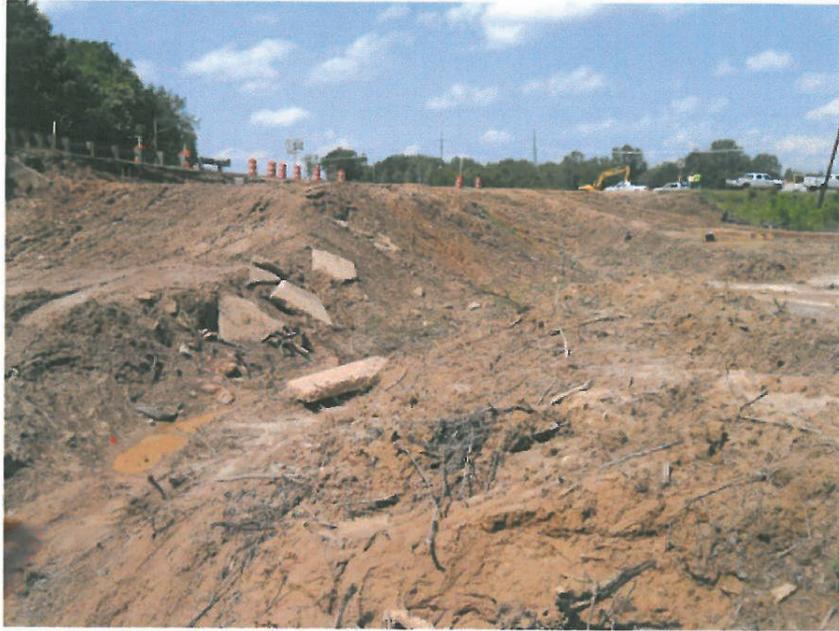
Photo B-9 No BMPs installed, no vegetation

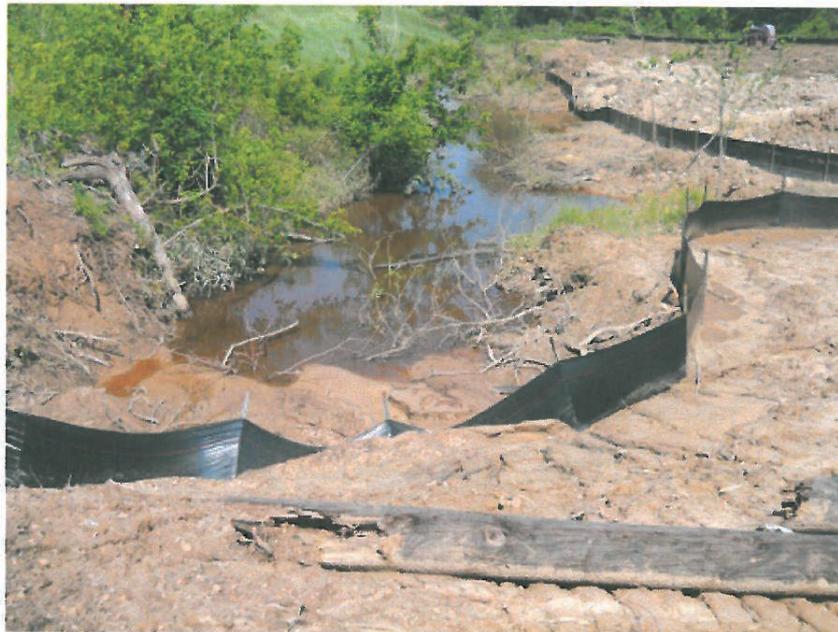
Photo B-10 Silt fence in need of maintenance

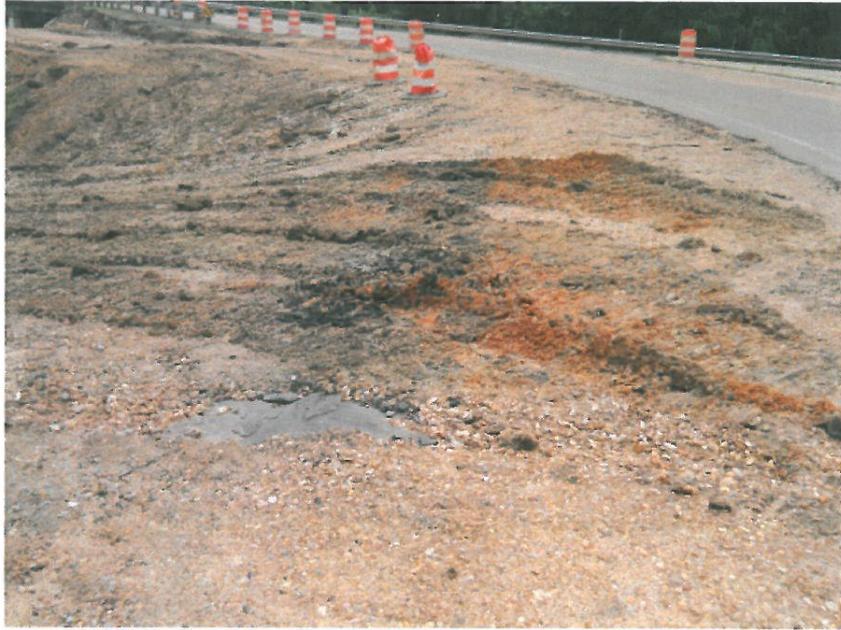
Photo B-11 Inadequate construction entrance

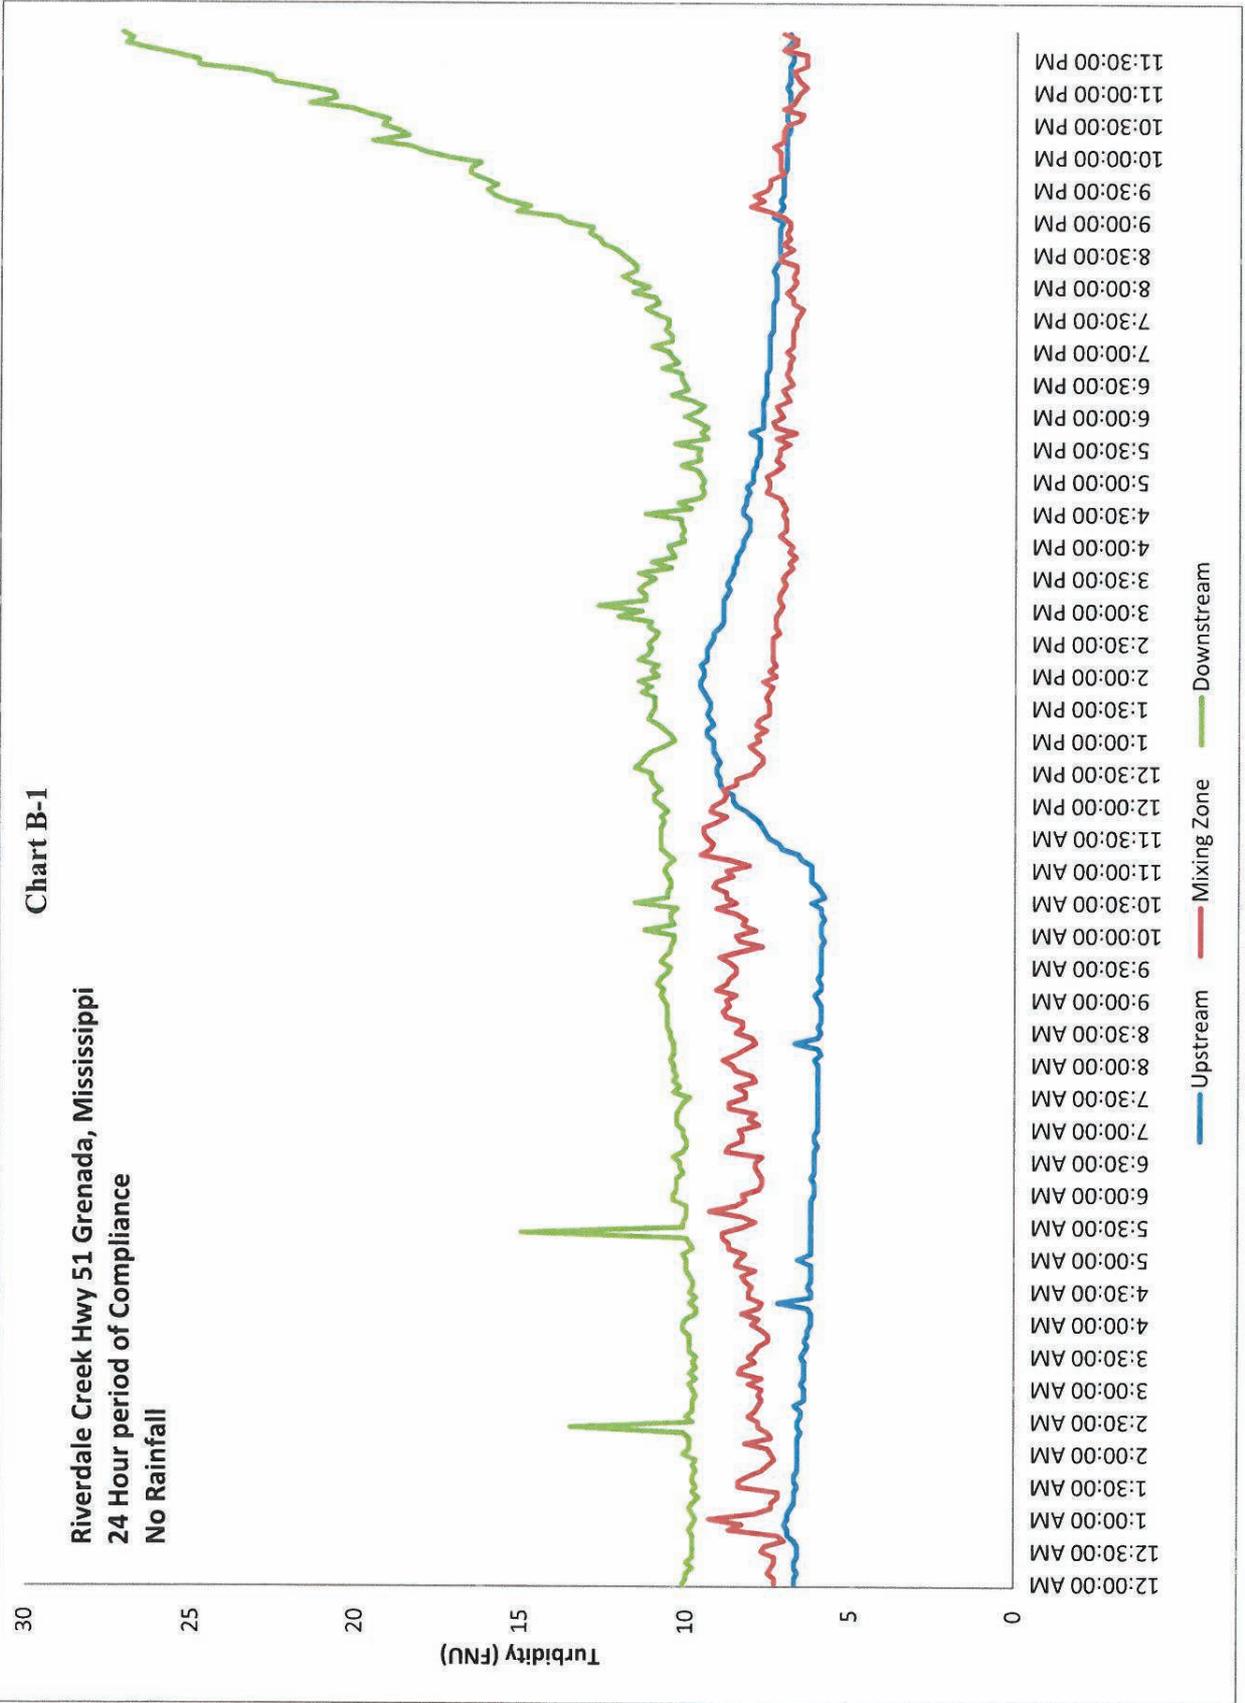
Chart B-1

Riverdale Creek Hwy 51 Grenada, Mississippi
24 Hour period of Compliance
No Rainfall

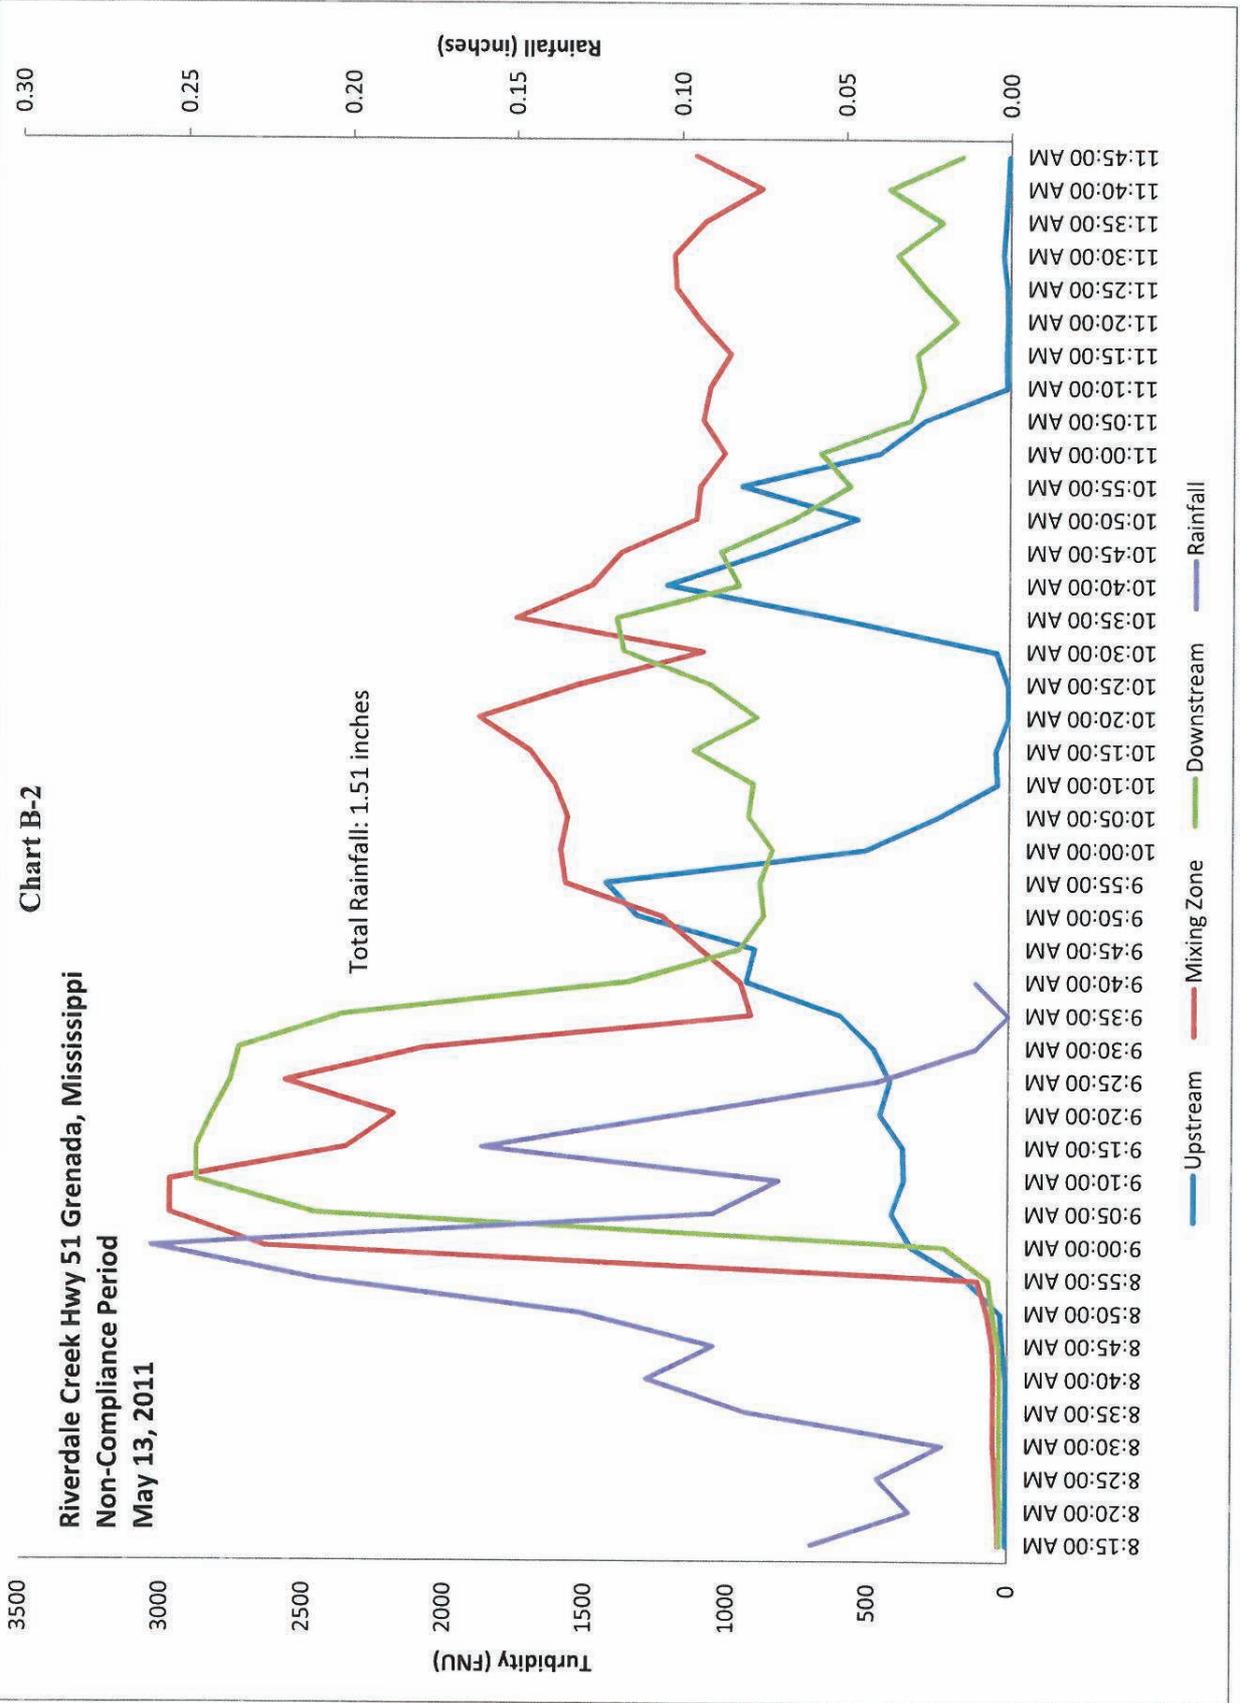
Chart B-2

Riverdale Creek Hwy 51 Grenada, Mississippi
Non-Compliance Period
May 13, 2011

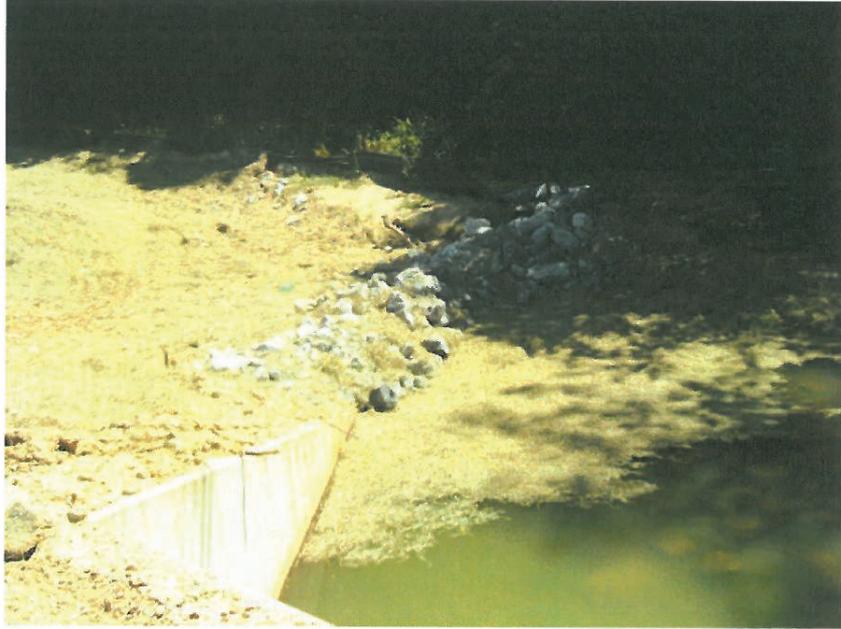
Photo C-1 Rock check dam installed, slope seeded and mulched

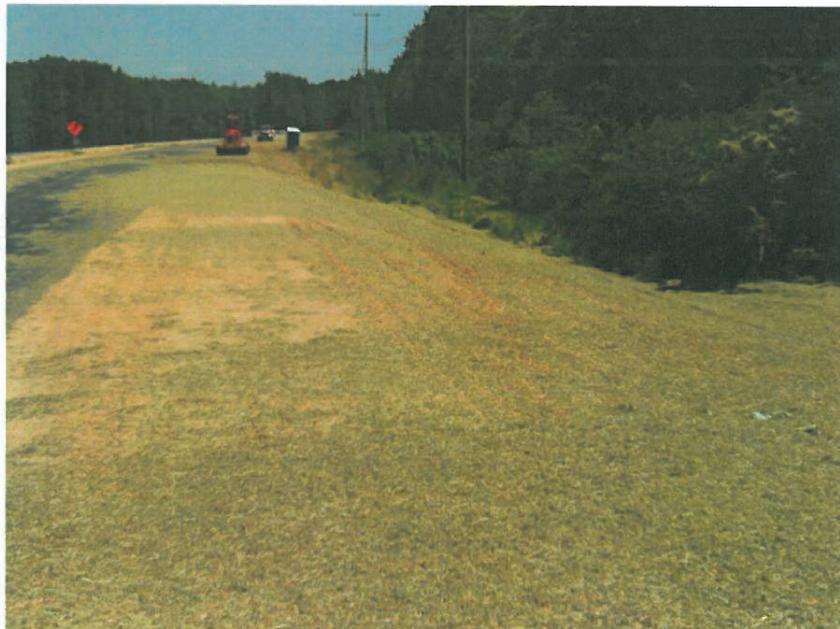
Photo C-2 Slope seeded and mulched

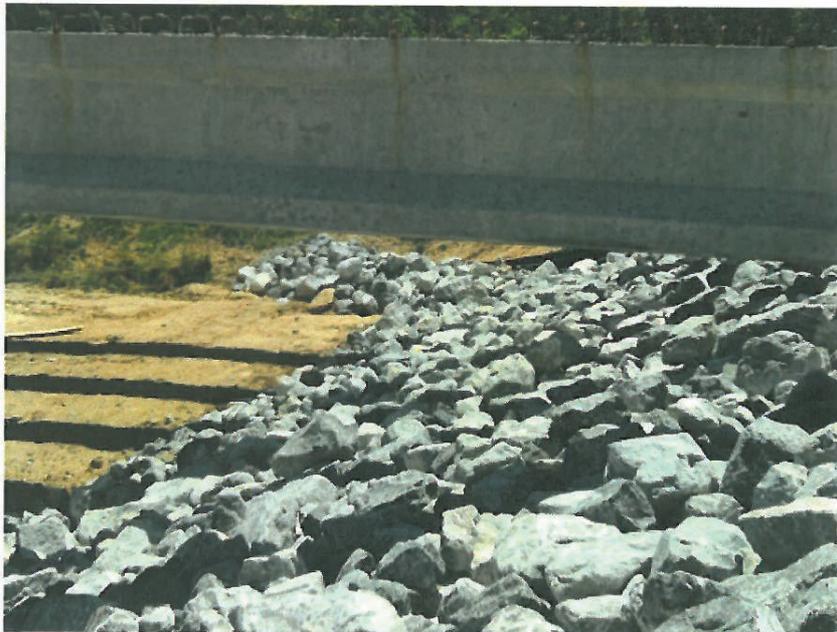
Photo C-4 Rip rap lined embankment

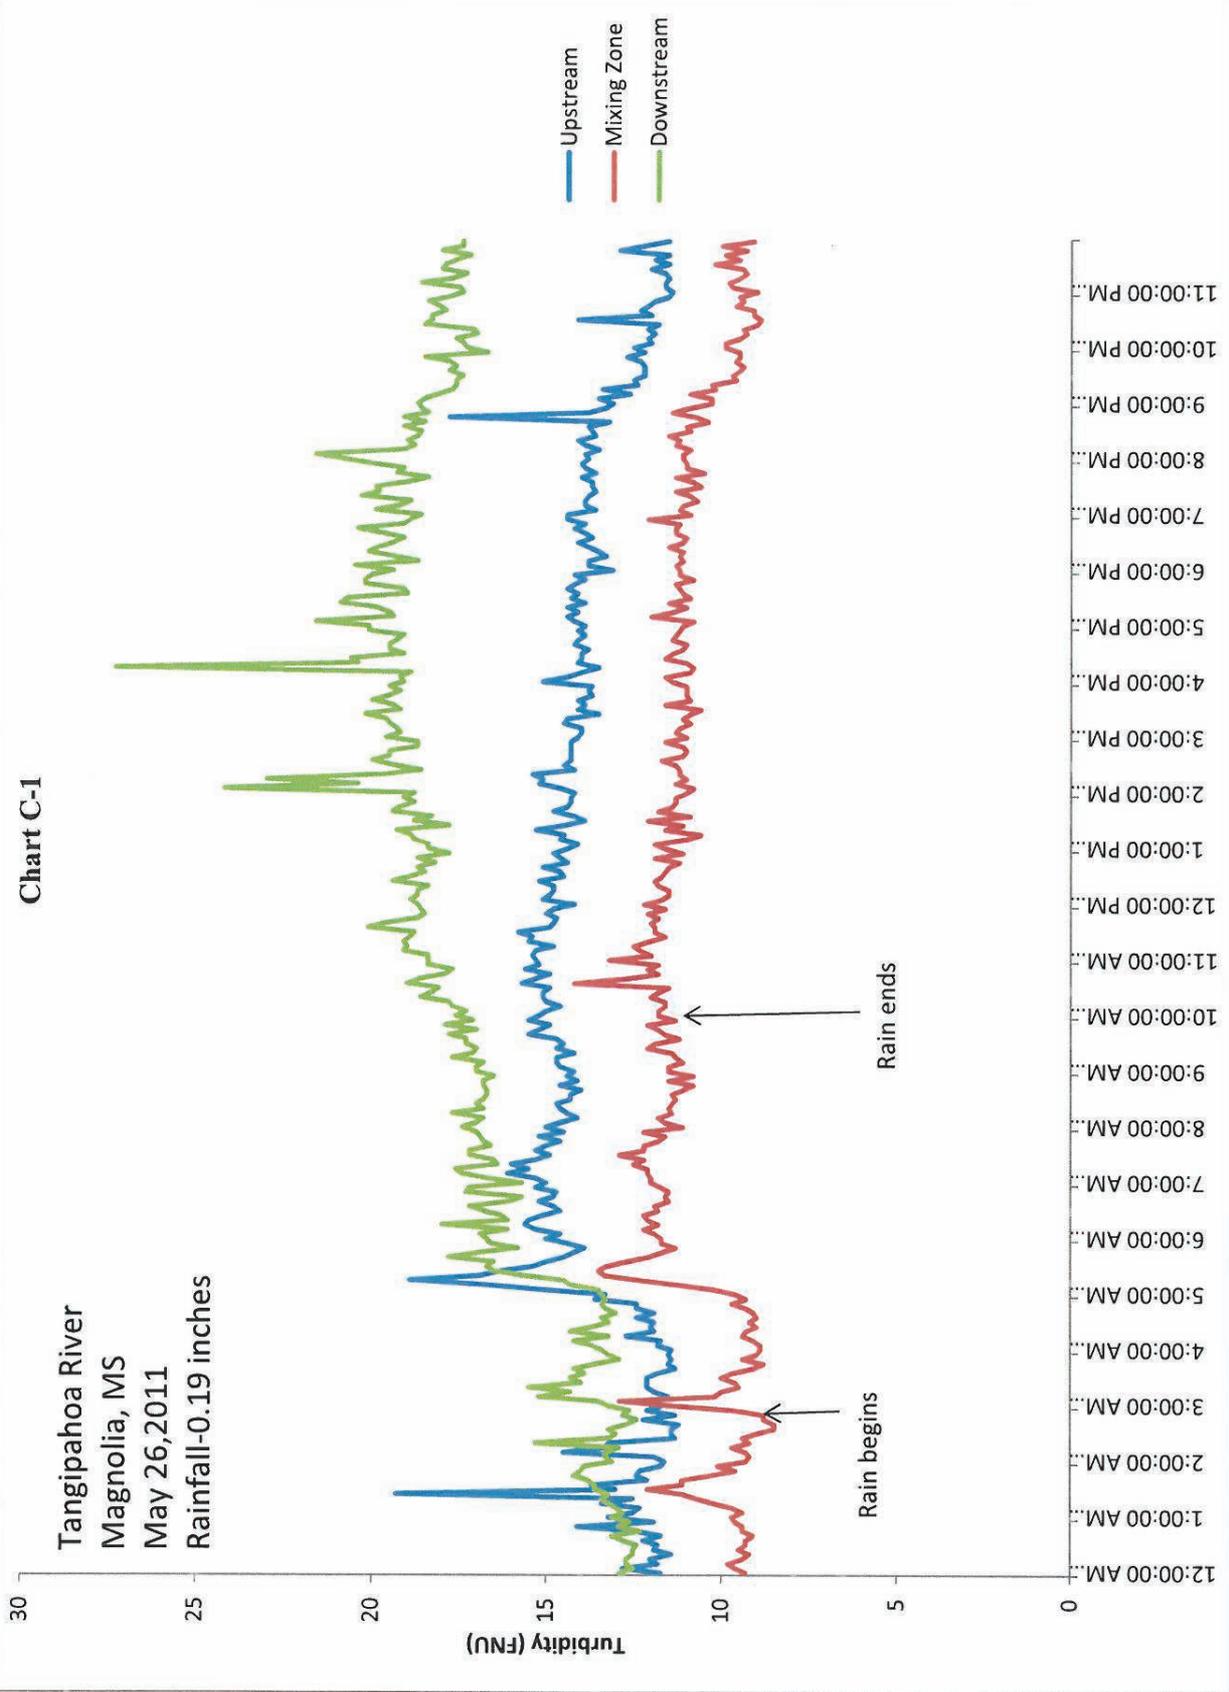
Chart C-1

Tangipahoa River
Magnolia, MS
May 26, 2011
Rainfall-0.19 inches

On May 17, 2011 this site was inspected by Thompson Engineering (Thompson) Stormwater Inspectors and was reported to have no deficiencies related to erosion and sedimentation control BMPs. On May 26, 2011 the site received 0.19 inches of rain between 02:54 and 09:59. The downstream turbidity remained within 50 NTU of the turbidity measured upstream for the duration of the rain event and throughout the monitoring period. In addition, turbidity measurements at this site remained well below the formerly proposed numeric limit of 280 NTU.

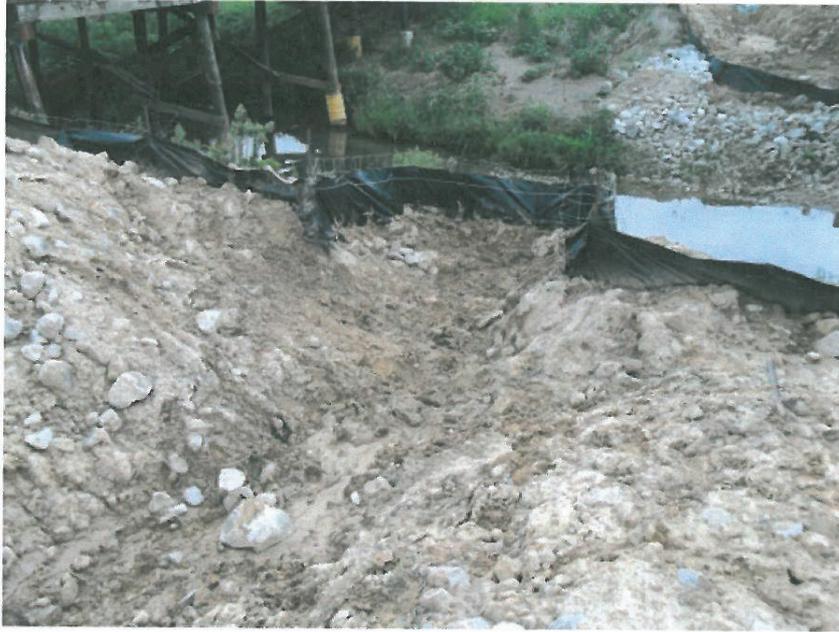
Photo D-1 Silt fence lining the stream channel

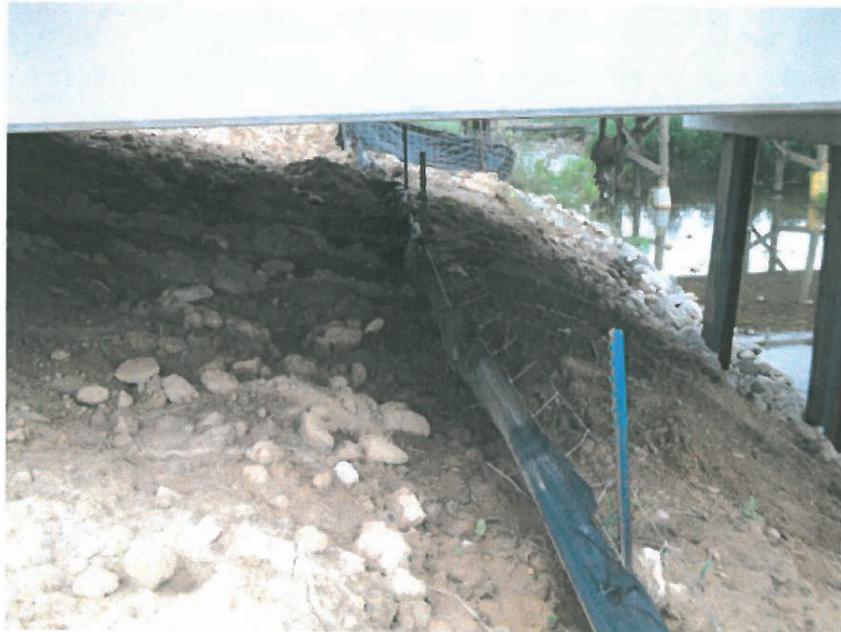
Photo D-2 Silt fence installed near the top of the stream bank

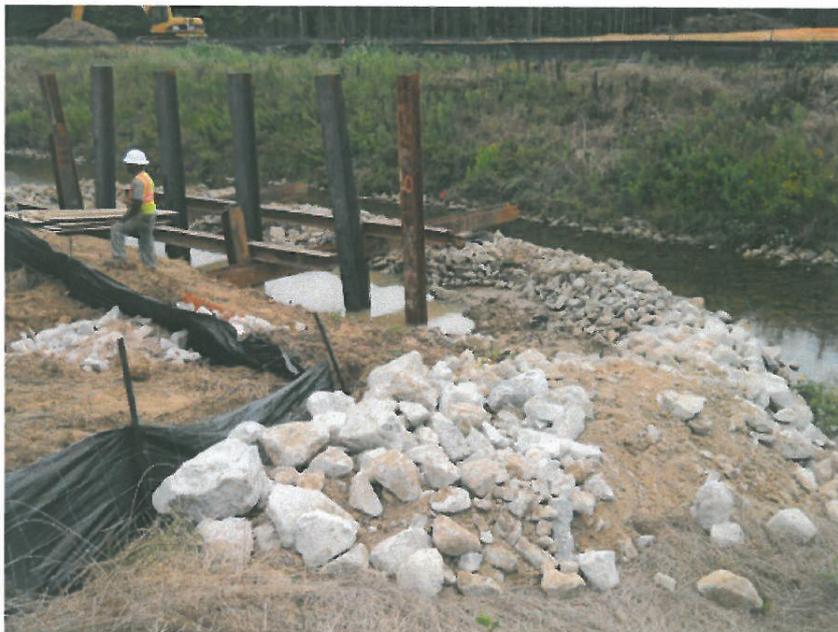
Photo D-4 Silt fence in need of maintenance, rip rap enclosed sediment basin

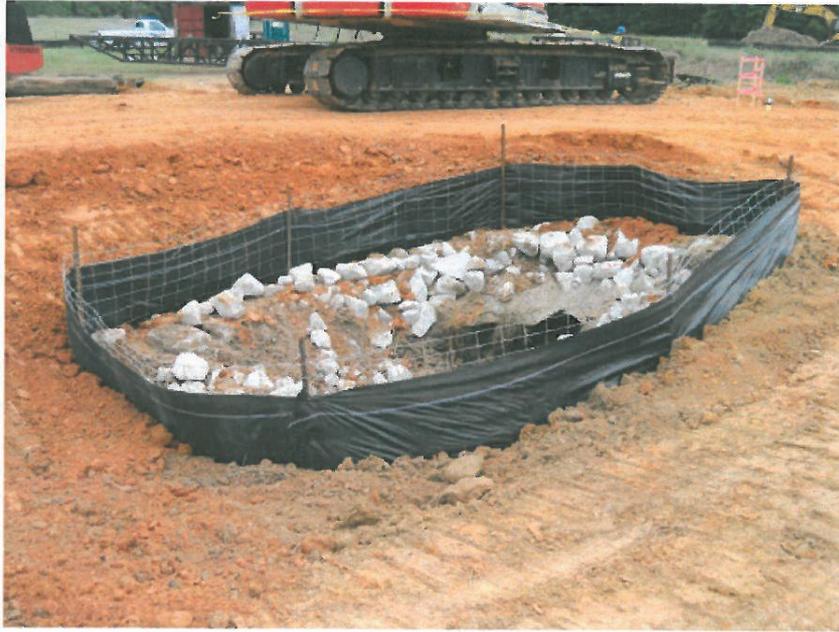
Photo D-5 Silt fence and rip rap installed around a drain inlet

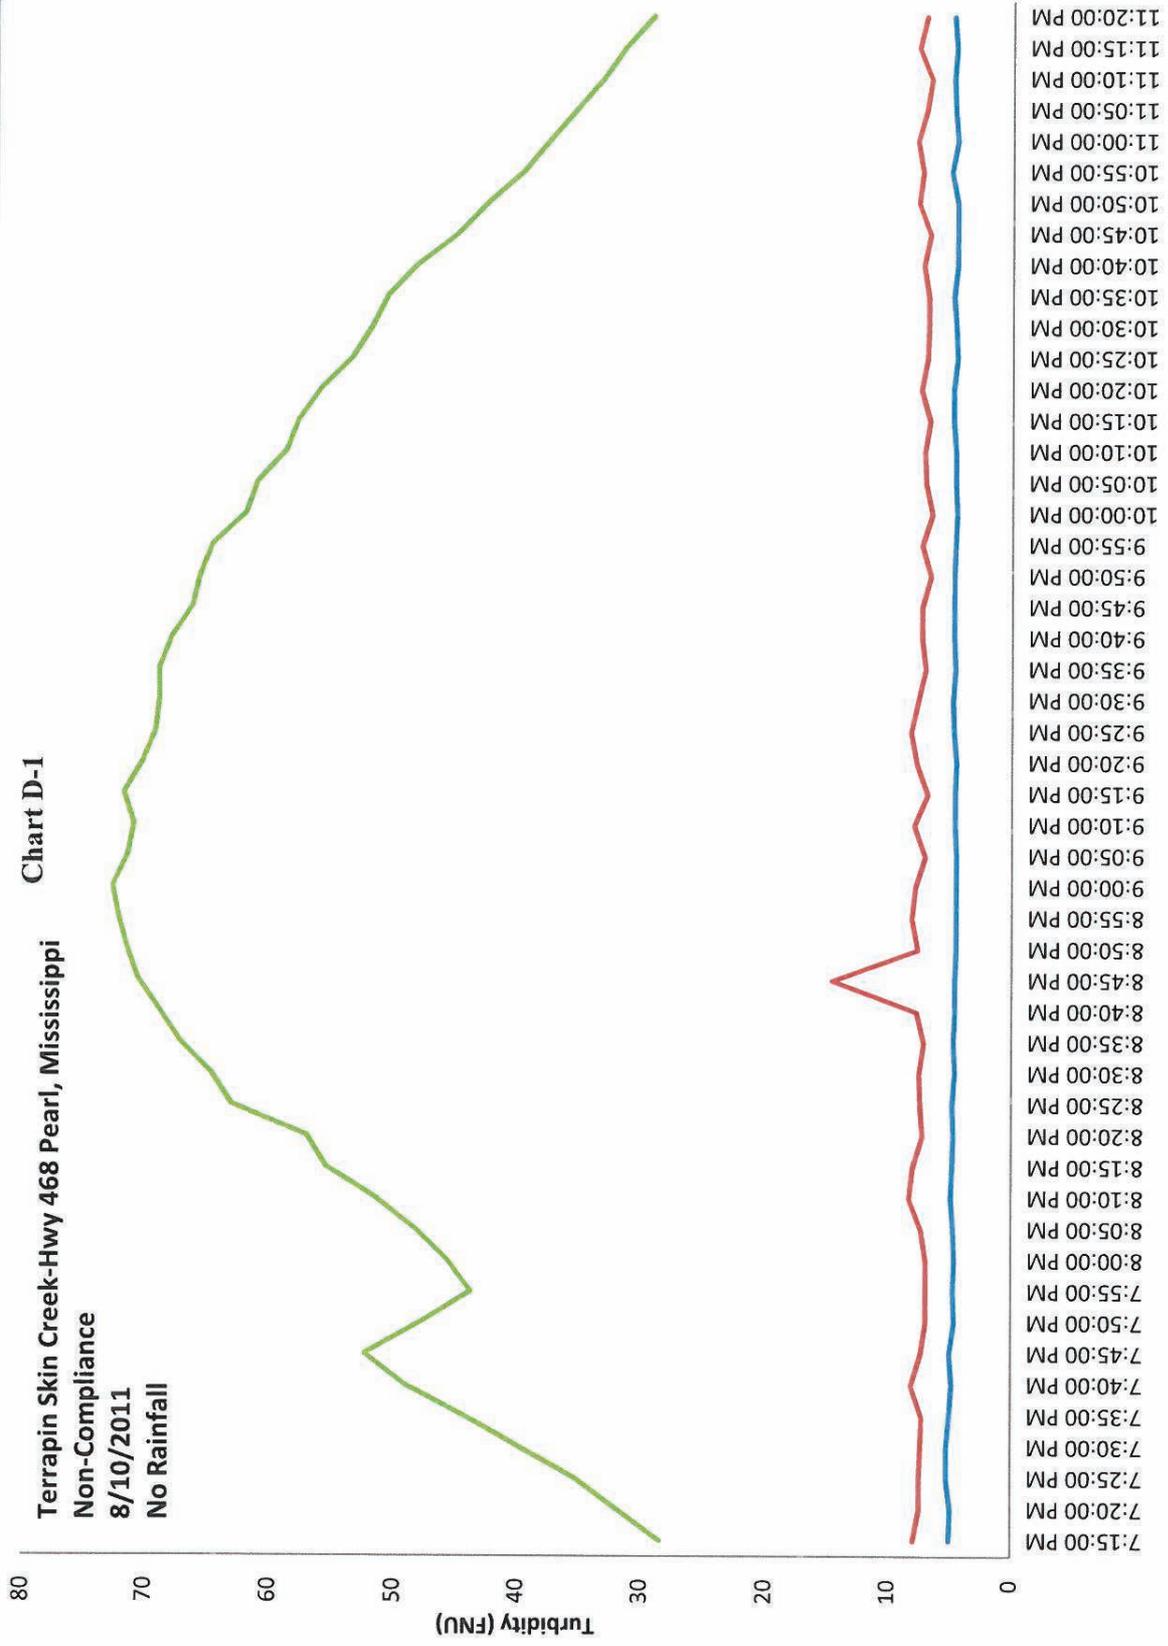
Chart D-1

8/10/2011

No Rainfall

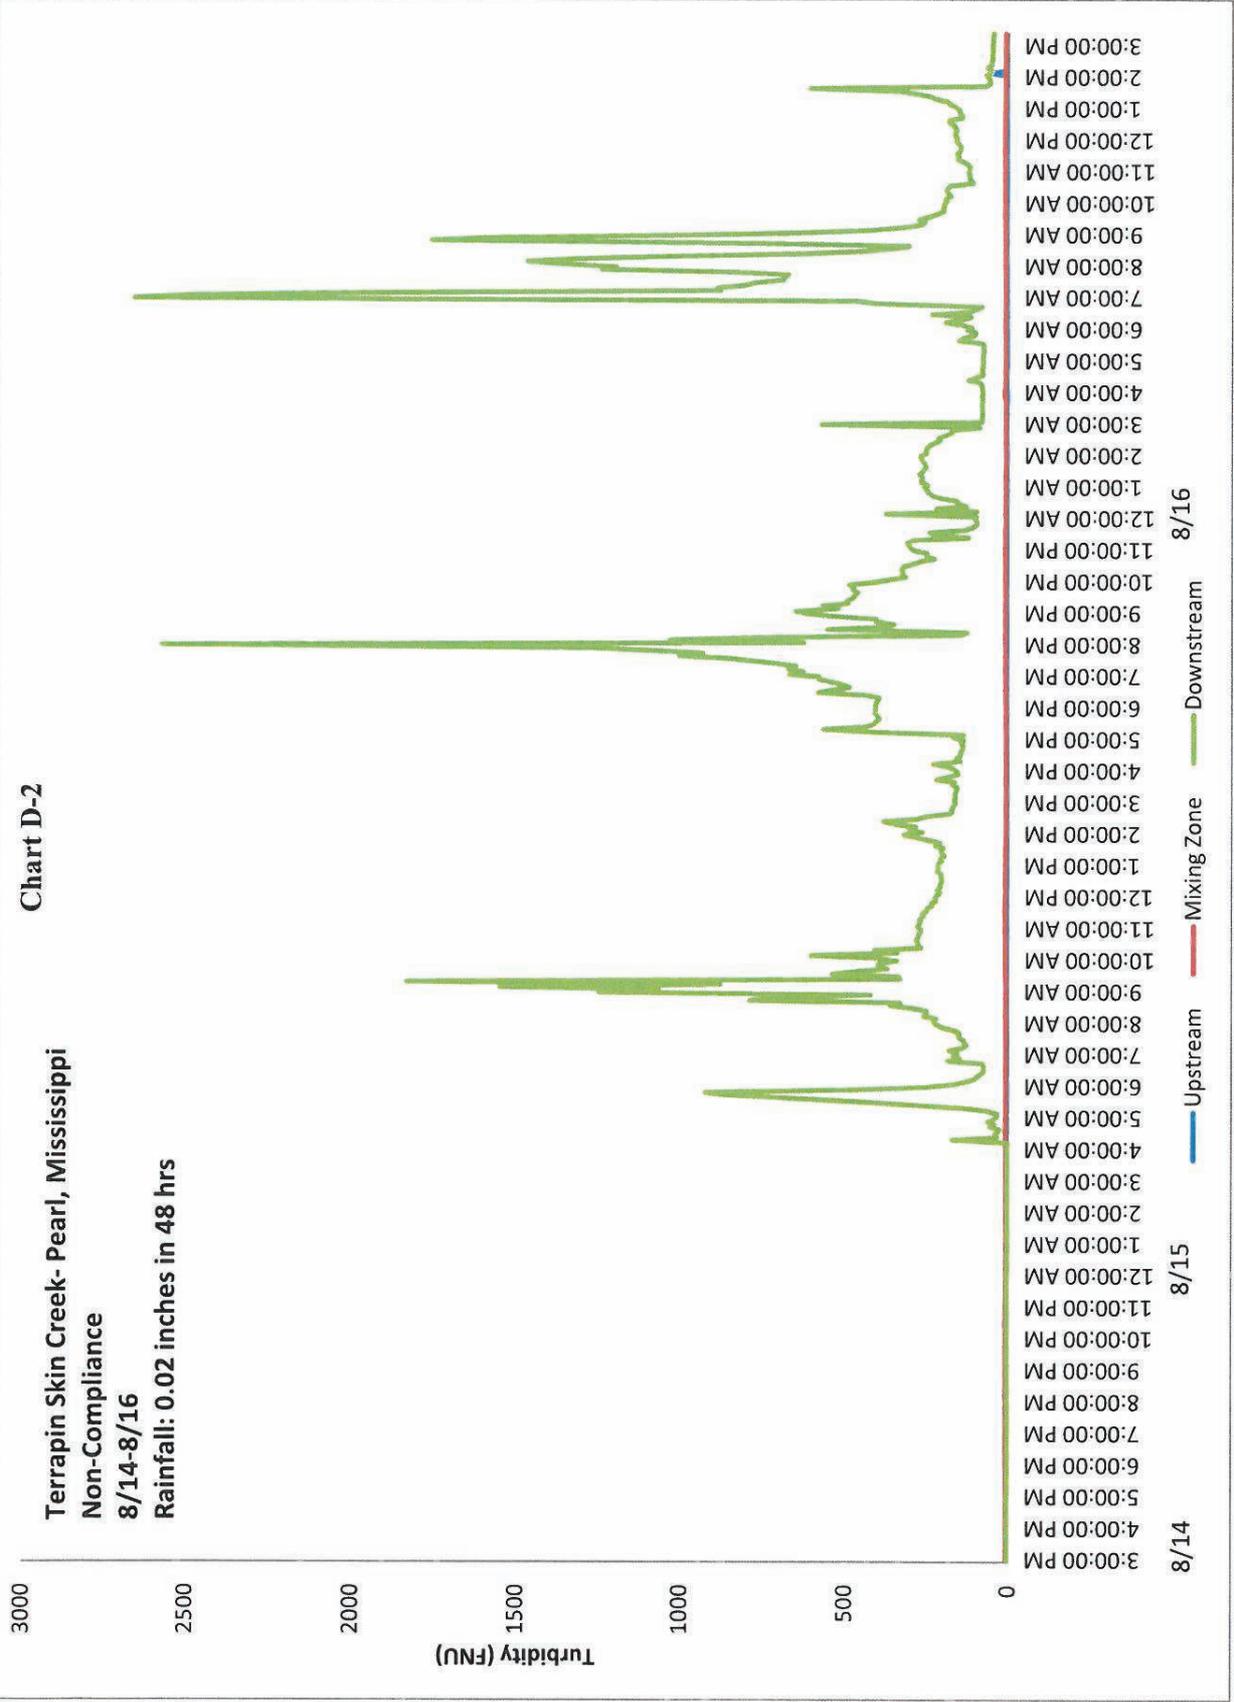
Chart D-2

8/14-8/16

Rainfall: 0.02 inches in 48 hrs

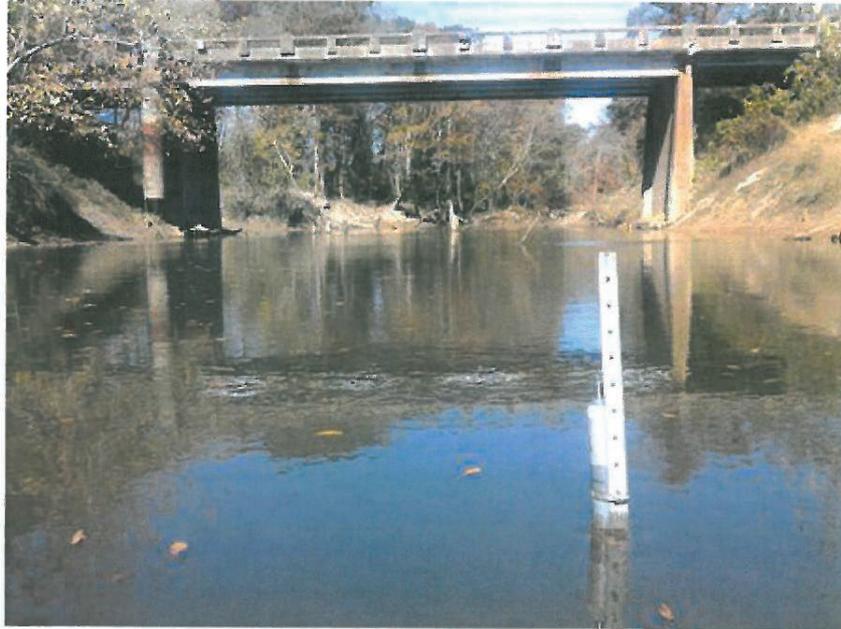
Photo E-1 Troll installed at the mixing zone sampling location

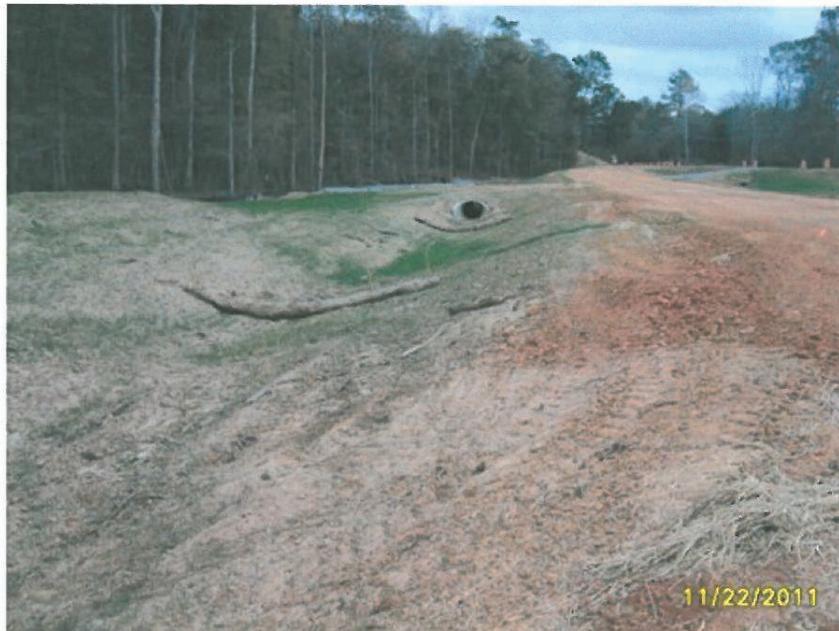
Photo E-4 Ditch banks mulched and seeded with waddles installed in the ditch

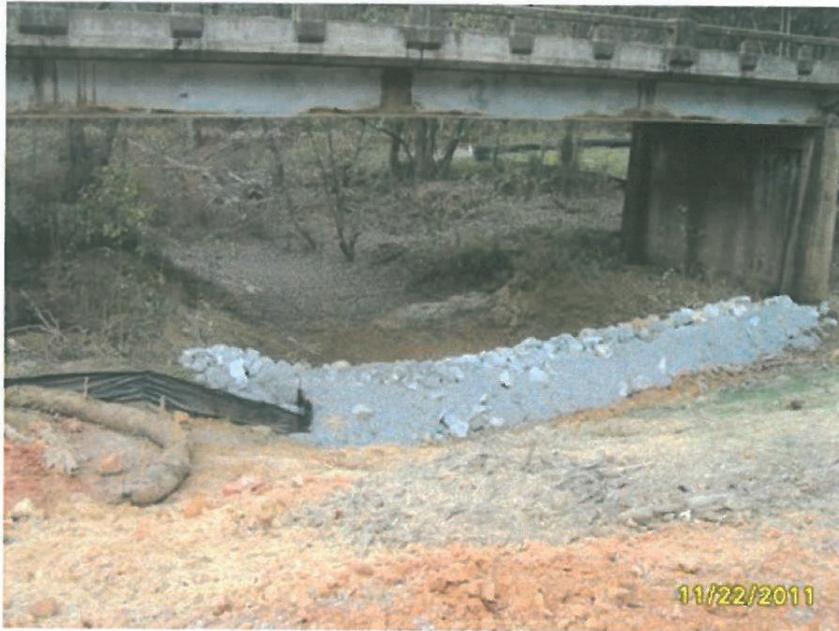
Photo E-7 Rock check dam at the inlet to a gulley leading to the stream
